**Flood Control Project Maintenance
Levee Inspections**

Fall 2012 Levee Maintenance Deficiency Summary Report

Sutter Maintenance Yard East Levee Sutter Bypass

Levee Inspection Report By Mile - Fall 2012

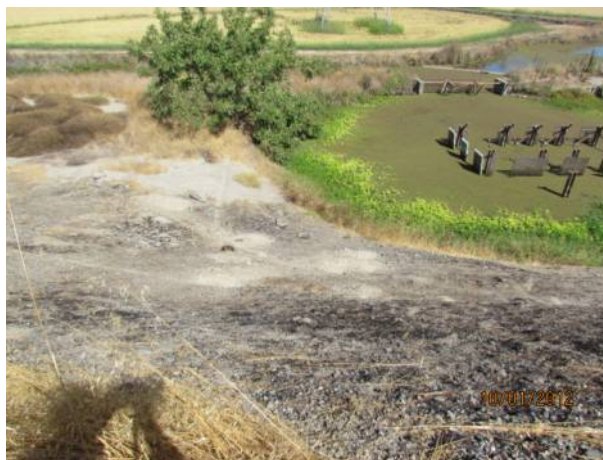
Levee Mile Report Line	4
Start Levee Mile	3.60
End Levee Mile	3.60
Location	Land Side
Category	Earthen Levee
Item	Animal Control

View of rodent activity along landside slope.

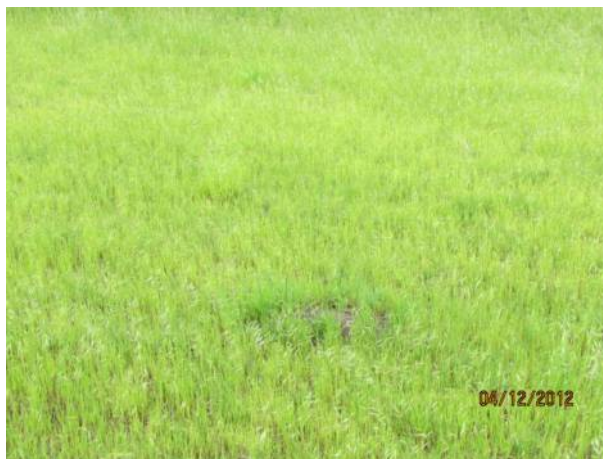
Levee Mile Report Line	5
Start Levee Mile	3.84
End Levee Mile	3.84
Location	Water Side
Category	Earthen Levee
Item	Animal Control

View of the grouted rodent holes.

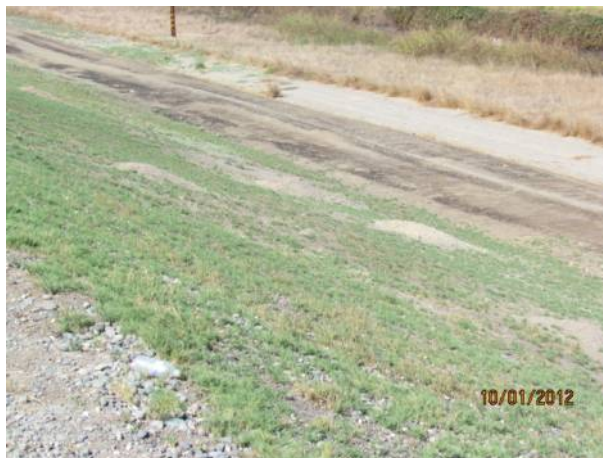
Levee Mile Report Line	6
Start Levee Mile	4.97
End Levee Mile	4.99
Location	Land Side
Category	Earthen Levee
Item	Animal Control

View of rodent activity along the landside slope.

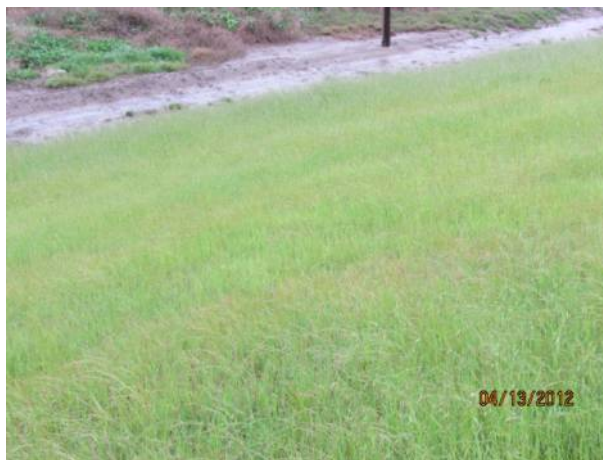
Levee Mile Report Line	8
Start Levee Mile	16.40
End Levee Mile	16.40
Location	Land Side
Category	Earthen Levee
Item	Animal Control

View of the grouted rodent hole.

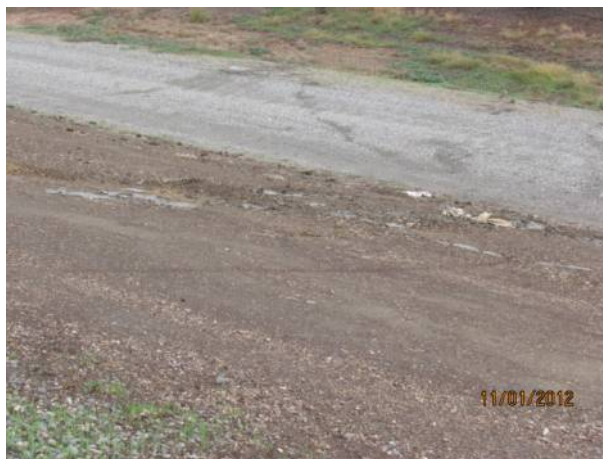
Levee Mile Report Line	9
Start Levee Mile	16.59
End Levee Mile	16.59
Location	Land Side
Category	Earthen Levee
Item	Animal Control

View of the grouting of the rodent holes along landside slope.

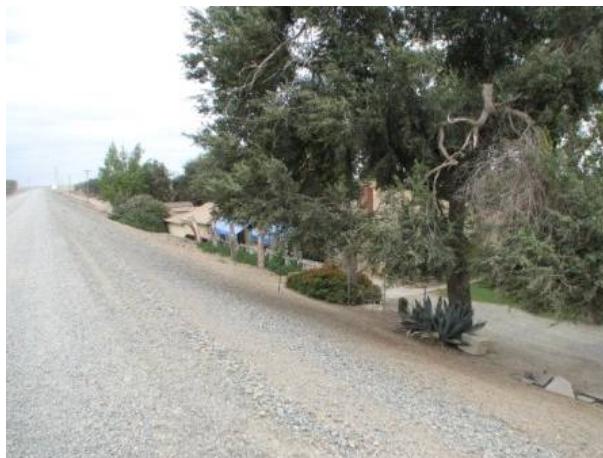
Levee Mile Report Line	10
Start Levee Mile	20.64
End Levee Mile	20.64
Location	Land Side
Category	Earthen Levee
Item	Encroachments

View of the building next to the landside toe of the levee.
